NASA CONTRACTOR REPORT 166 334

**The Influence of Microstructure on the
Resistance of Low Strength Ferrous Alloys
to Gas Phase Hydrogen Degradation**

Harry F. Wachob

Failure Analysis Associates

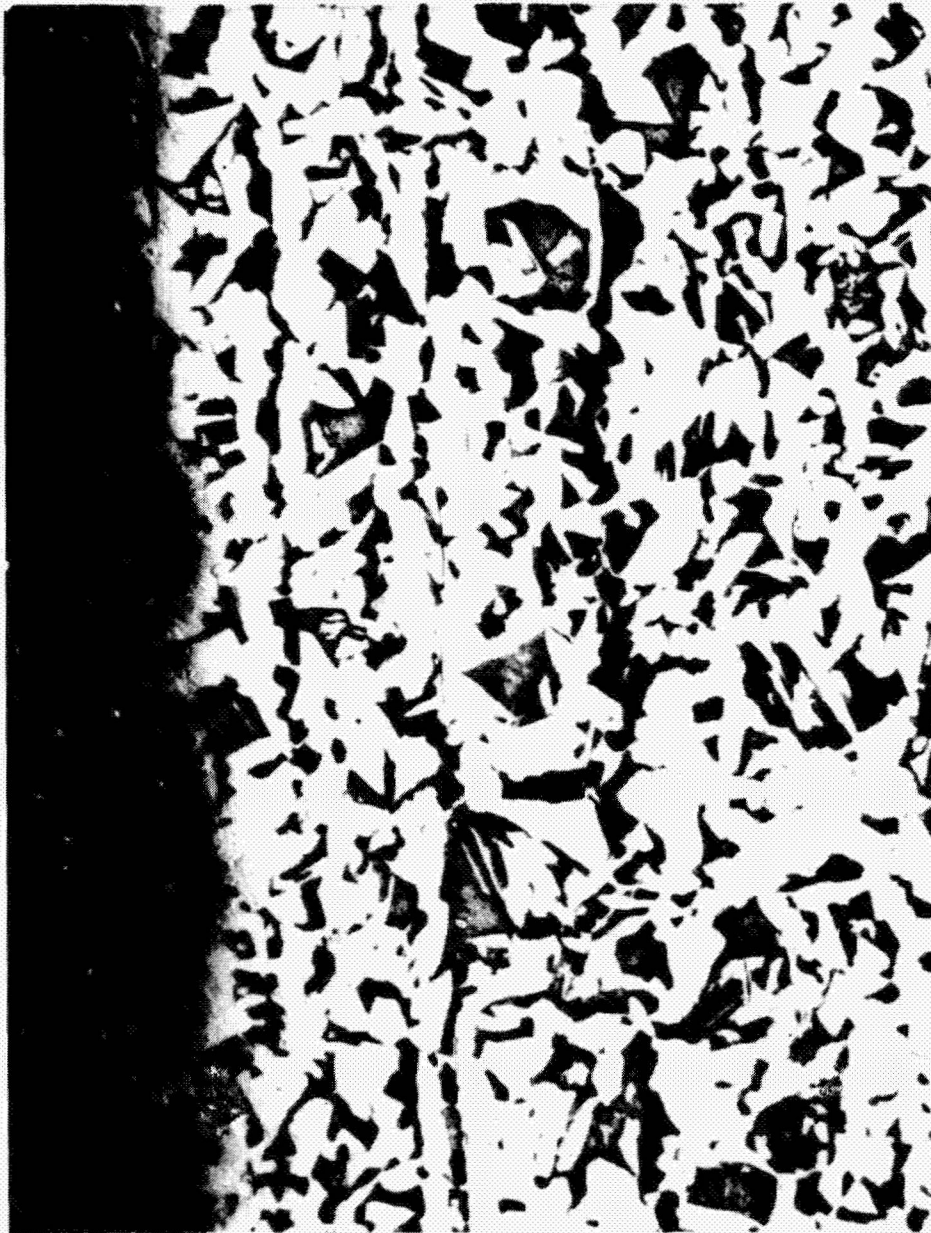
Figure 1 - Microstructure of a Normalized A516-G70.

A wide range of microstructures and strengths were obtained after the heat treatment of A516. The normalized microstructure is the typical banded pearlite-ferrite commonly seen in hot rolled plate. A representative micrograph of the 70% ferrite - 30% pearlite normalized (900°C) structure is shown in Figure 1. An example of the quench and tempered martensitic structure (1200°C) exhibiting the typical acicular or needlelike martensite platelets is shown in Figure 2. The third microstructure tested is that of an isothermally quenched bainitic or upper pearlitic material. This material has approximately 10% free ferrite in a continuous network at the prior austenite grain boundaries. The overall microstructure and a higher magnification micrograph of a free ferrite region are shown in Figures 3 and 4.

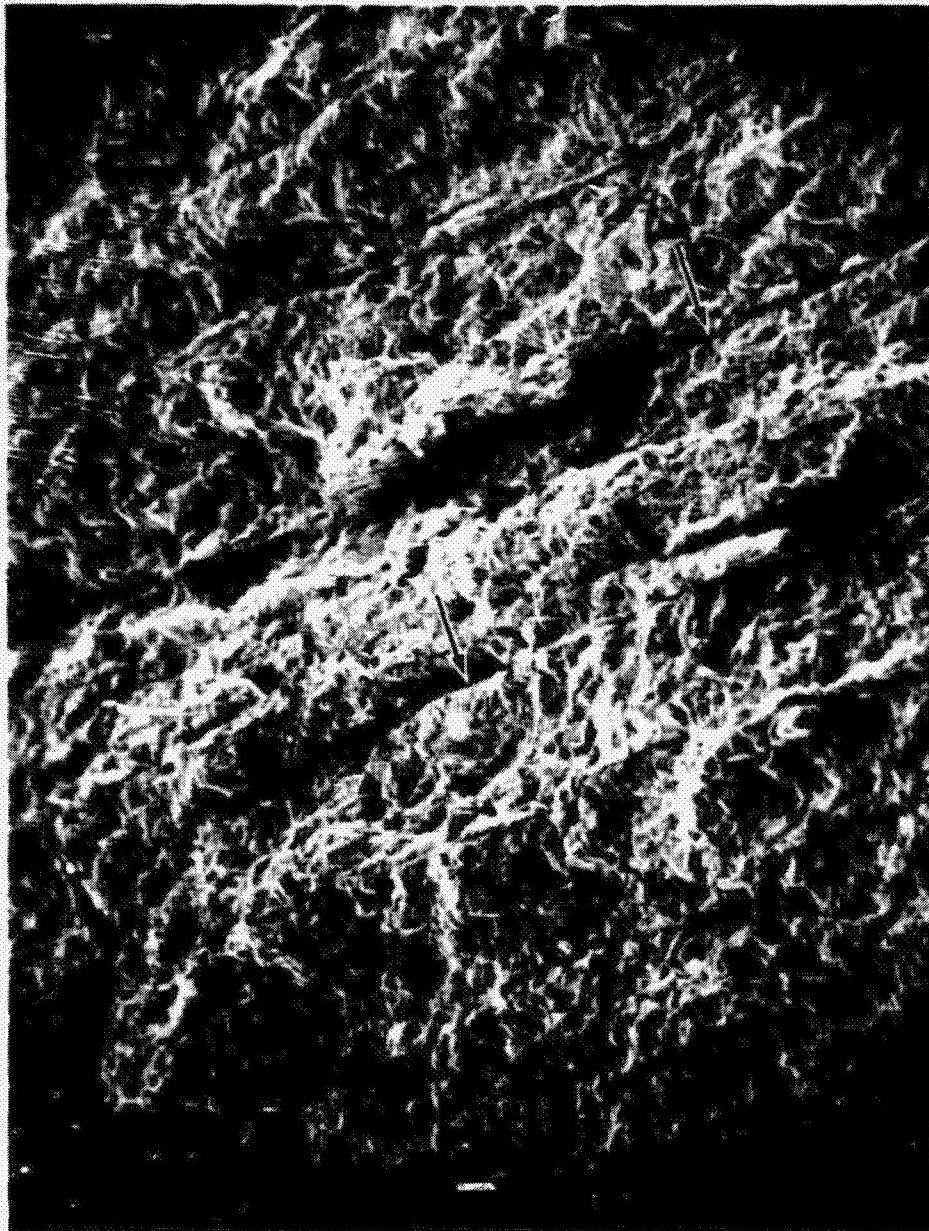
Figure 12 - MnS Domination of Fatigue Fracture.

1. Fatigue striations and ductile tearing of the α -ferrite, as shown in Figure 11, are the result of plastic blunting and resharpening of the crack tip.
2. Strong influence of the rolling inclusions of MnS, appeared as sharp elongated secondary cracks on the fracture surface, as indicated by the arrows in Figure 12.
3. Frequent secondary cracks along the pearlite- α -ferrite interface, as is shown in Figure 13.

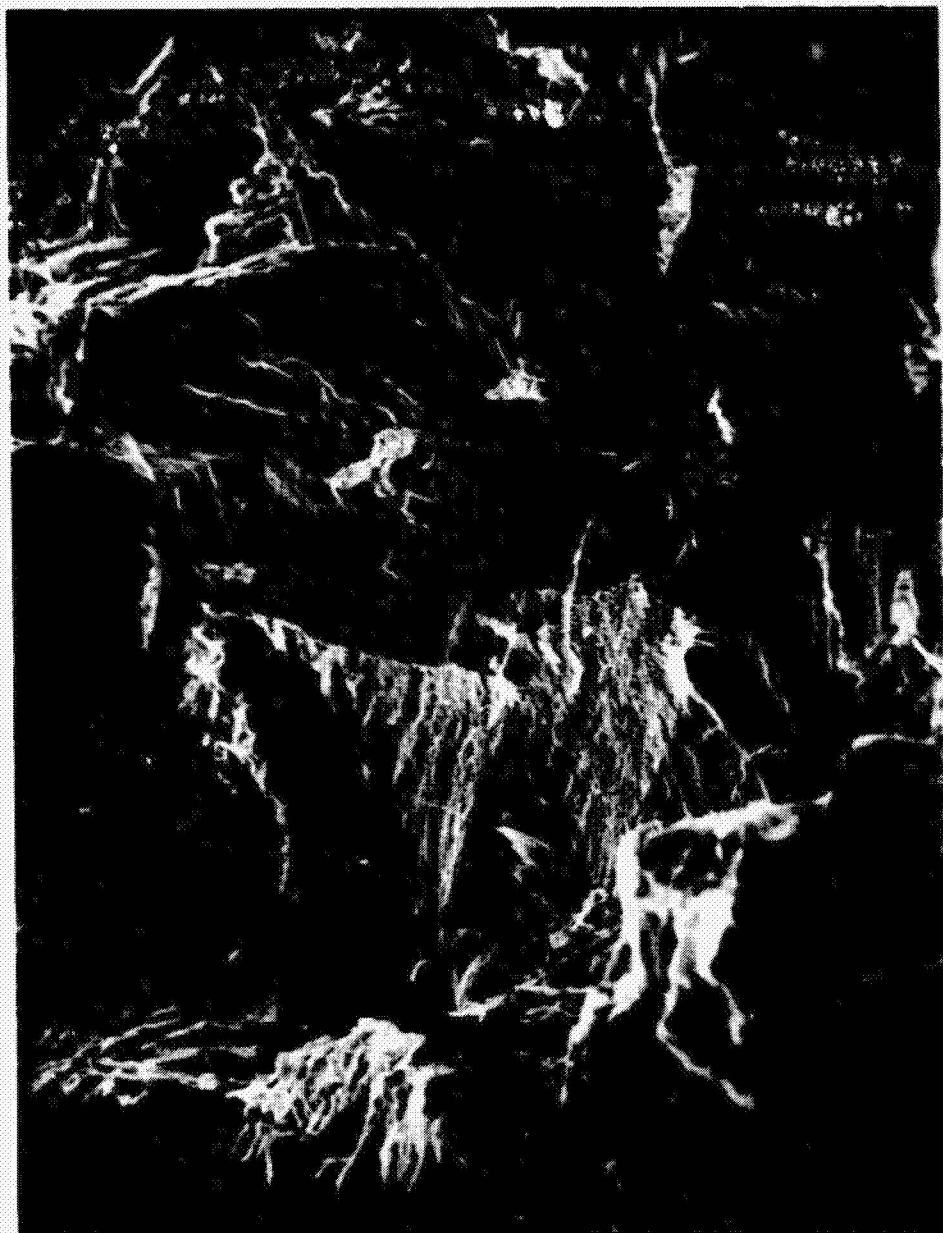
Figure 14 - Transgranular Fracture of A516 in 6.9 MPa H₂.
 $\Delta K \approx 24 \text{ MPa} \cdot \text{m}^{1/2}$

1. At $\Delta K = 24 \text{ MPa} \cdot \text{m}^{1/2}$, a transgranular mode of failure through both pearlite and ferritic grains occurred, an example of which is shown in Figure 14. In addition to the transgranular failure, evidence of secondary cracking and MnS inclusion effects were absent.
2. At a slightly lower ΔK , $\sim 17 \text{ MPa} \cdot \text{m}^{1/2}$, small amounts of intergranular failure were observed among the general transgranular features. These features were accompanied by a the reduction in the overall amount of ductile tearing.
3. Finally, at ΔK values $< 12 \text{ MPa} \cdot \text{m}^{1/2}$, the fracture surface was primarily intergranular in nature. These intergranular failures occurred at both ferrite-ferrite and ferrite-pearlite boundaries. Figure 15 and 16 illustrate the general appearance of the intergranular failure at low and high magnifications respectively.

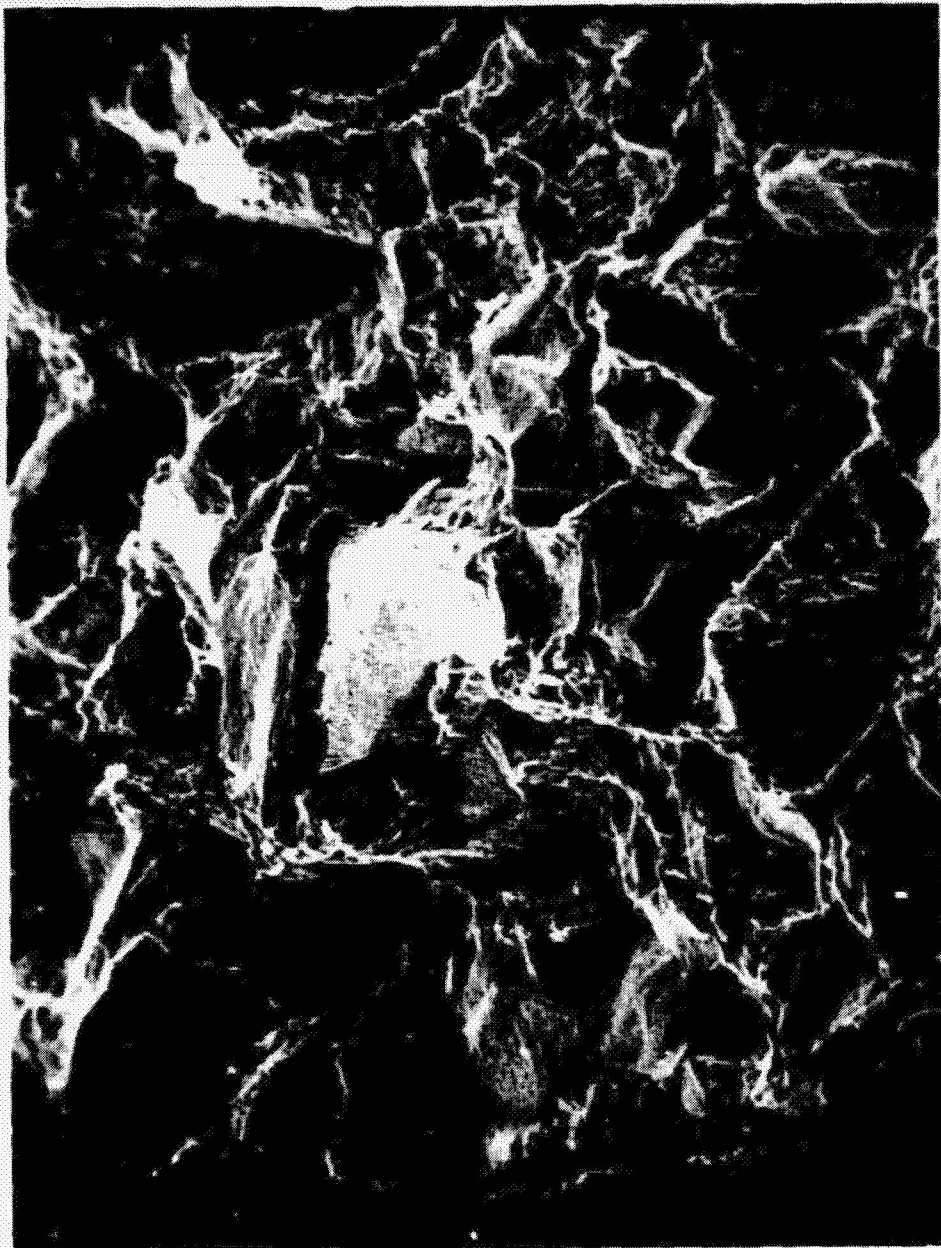
Figure 15 - Intergranular Failure of A516 in 6.9 MPa H_2 .
 $\Delta K \approx 12 \text{ MPa} \cdot \text{m}^{1/2}$

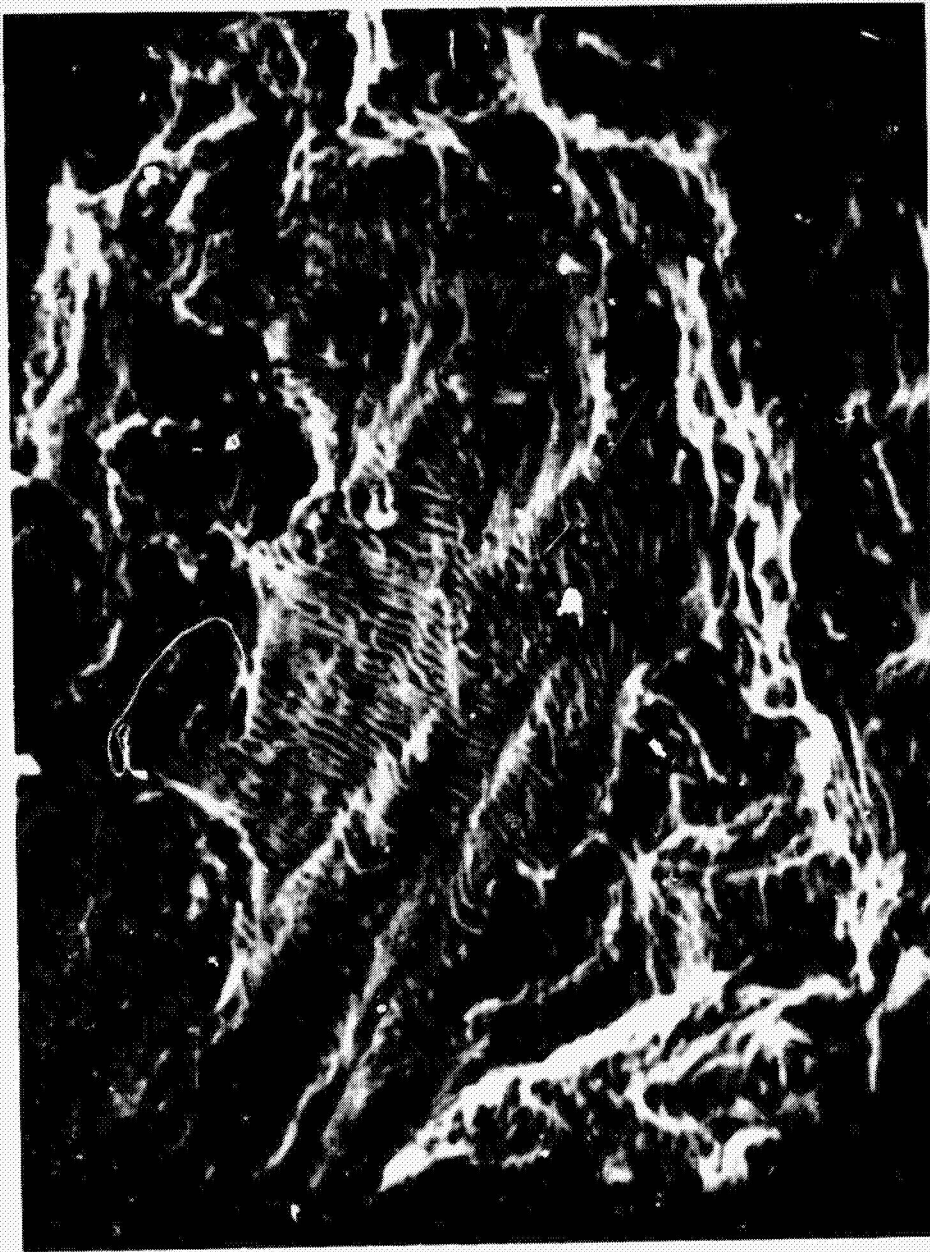
Figure 19 - Intergranular Failure of a Bainitic Specimen After Air Fatigue.

Bainitic failure surfaces produced in air show some evidence of plastic tearing, transgranular failure, and small amounts of intergranular separation at ferrite-pearlite boundaries. Several of these features and the reduction of secondary cracking at MnS inclusion sites, indicated by arrows, are shown in Figure 17. Only the microstructures austenitized at 1200°C showed evidence of globular or cylindrical MnS inclusions. Those specimens treated at 900°C had large platelet MnS inclusions which acted as secondary crack initiation sites. There are some indications that the crack front in the bainitic specimens followed the lath interface which resulted in the herringbone appearance in Figure 18. The failure surface also contains an intergranular component. This mode of failure, independent of environment, always occurs at the ferritic-pearlitic boundaries an example of which is shown in Figure 19. This interface was the result of the isothermal tempering. This resultant microstructure is a combination of upper bainite, fine pearlite, and free ferrite at the prior austenite grain boundaries, as was seen earlier in Figures 3 and 4.

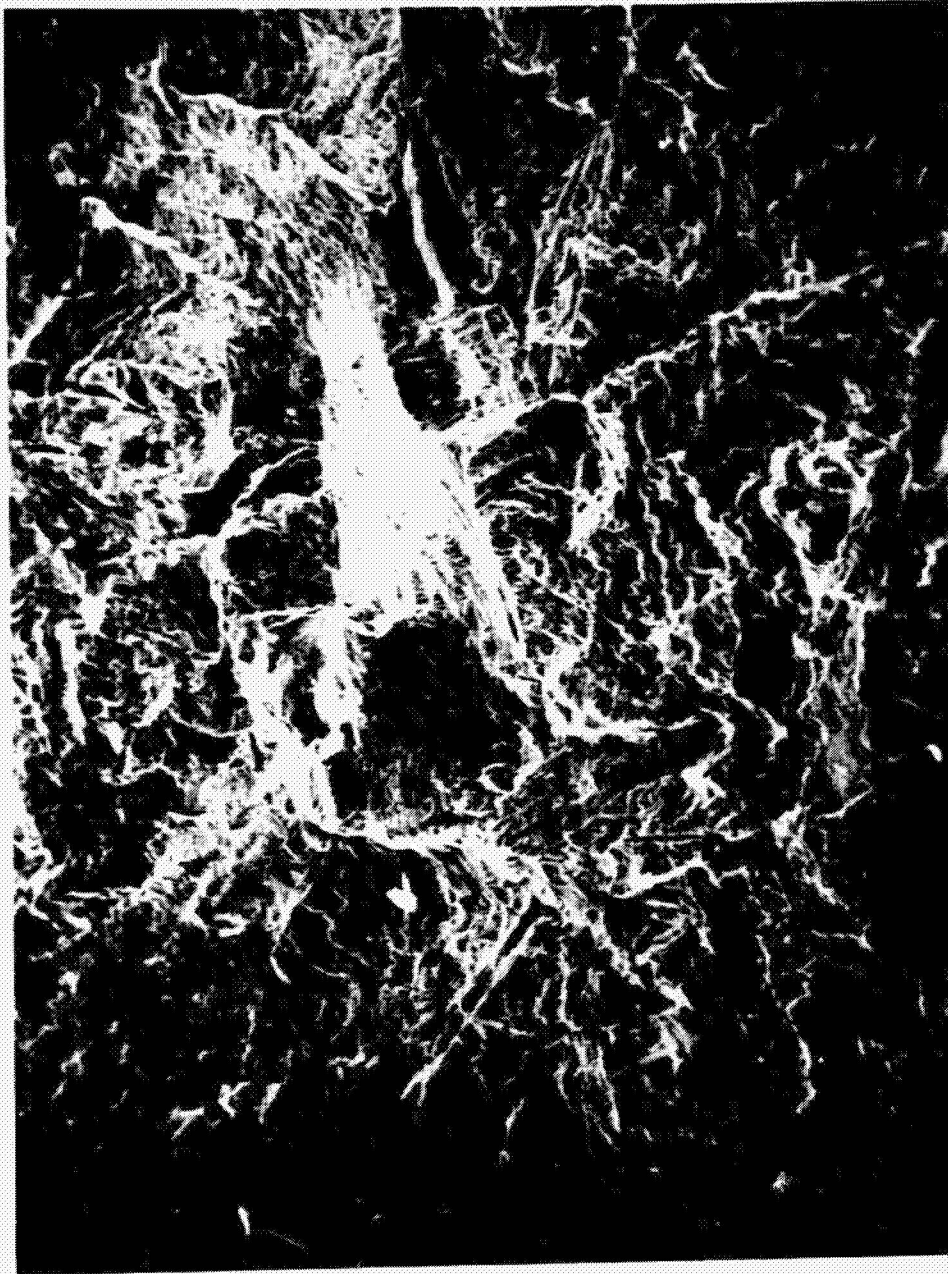
Figure 20 - Fractography of Bainitic Specimen After
Fatigue in 6.9 MPa H_2 .

the grain boundary ferrite were also observed. These features are illustrated in low and high magnification fractographs in Figure 20 and 21. Again, the fracture path is dominated by the bainitic lath and grain boundary ferrite.

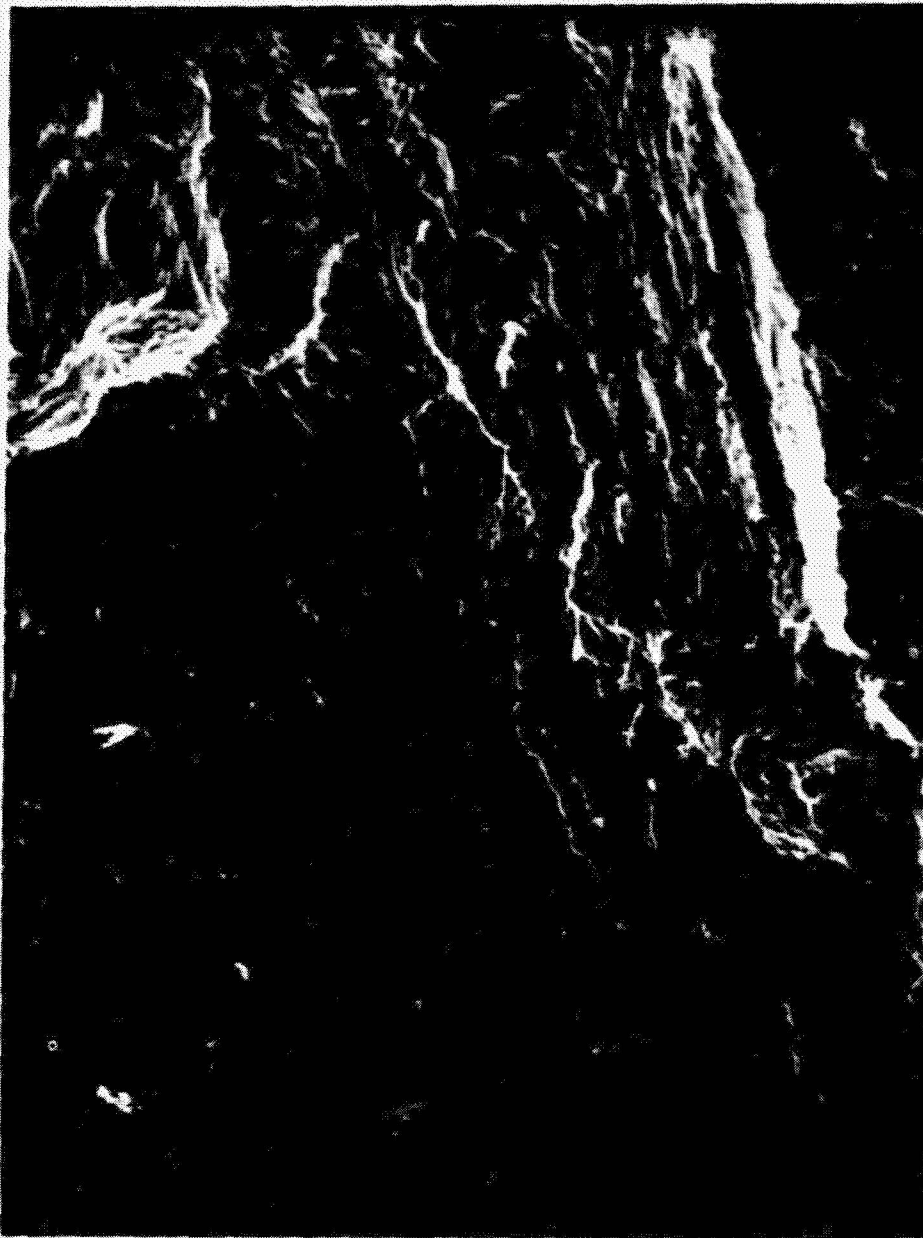
Figure 21 - Transgranular Failure in a Bainitic Specimen After Fatigue in 6.9 MPa H_2 .

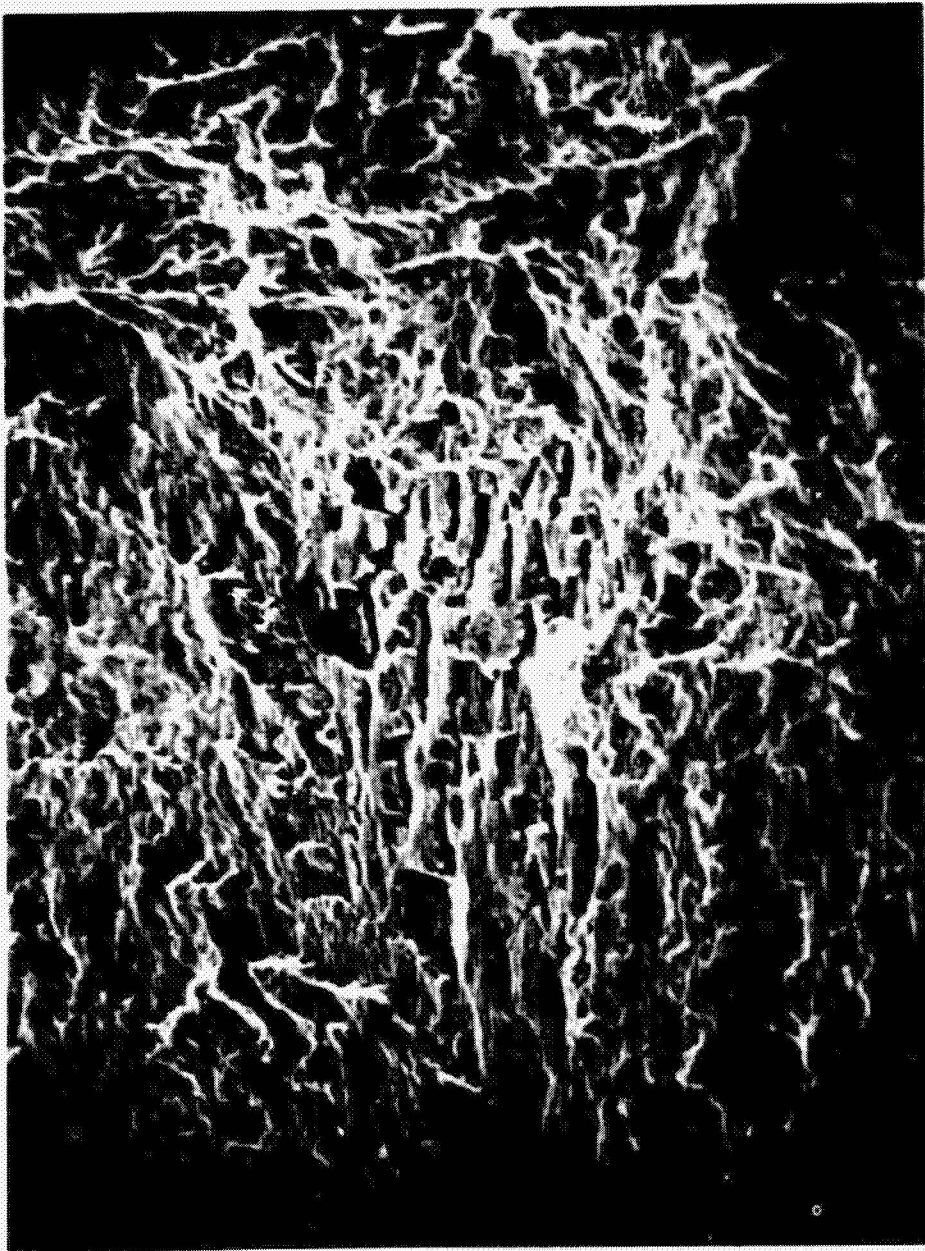
Figure 23 - Transgranular Failure Surface of a Martensitic Specimen After Fatigue in Air.

Martensitic fractographic features are similar to those observed on the bainitic failure surface. The fracture path in air, shown in Figure 22, is crystallographic in nature due to the martensitic packet morphology. At higher magnification, see Figure 23, plasticity and the strong influence of the martensitic microstructure on the failure surface can be seen. In the hydrogen environment, the transgranular failures exhibit less plasticity, as is illustrated by Figure 24 and 25. Additionally, the amount of intergranular failure increases to approximately 10%.

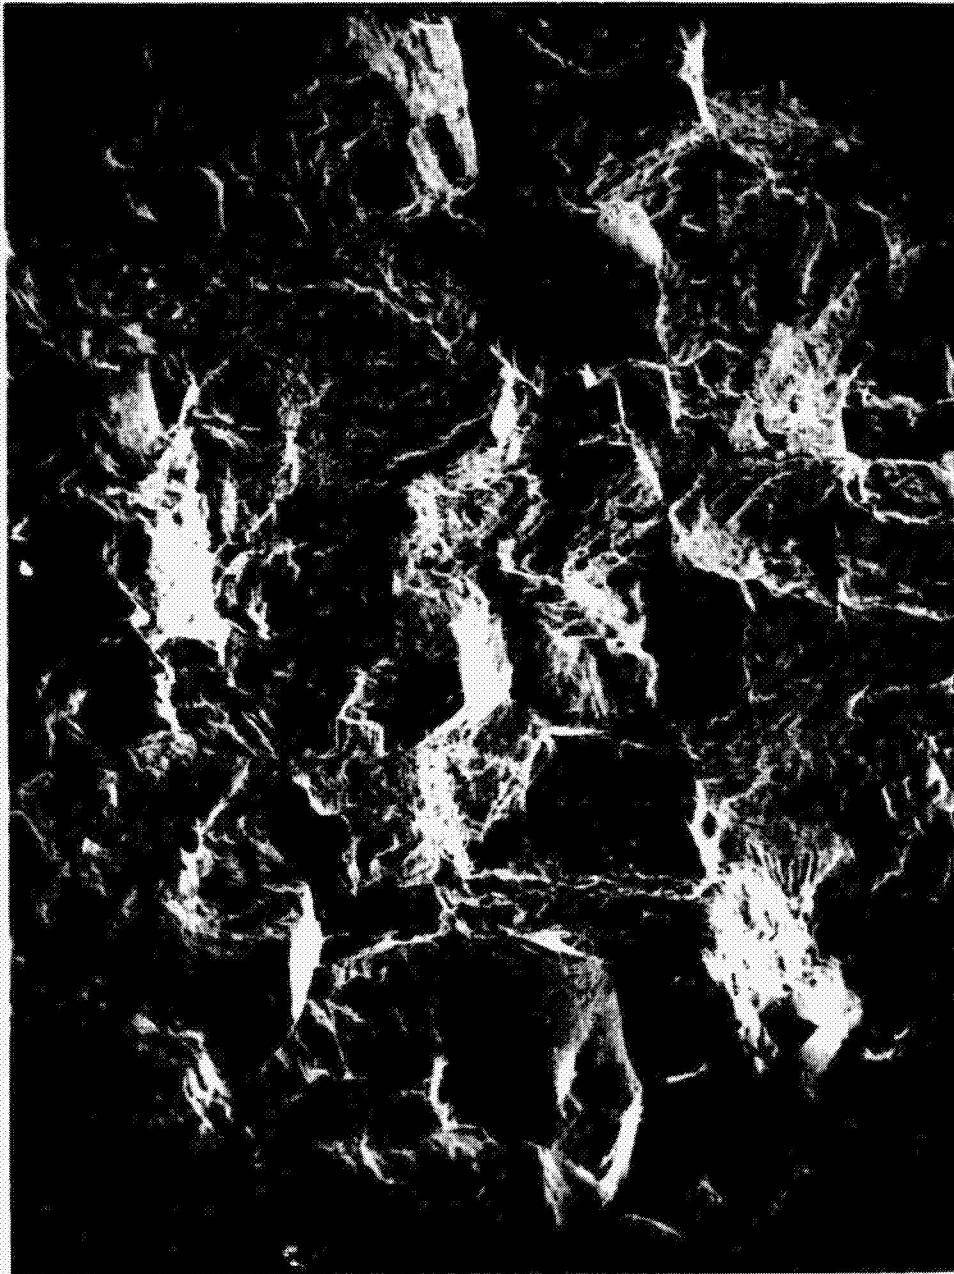
Figure 24 - Typical Martensitic Fracture Surface
Produced by Fatigue in 6.9 MPa H_2 .
